CTS Focus

Conservation restoration in Hvar and Kotor

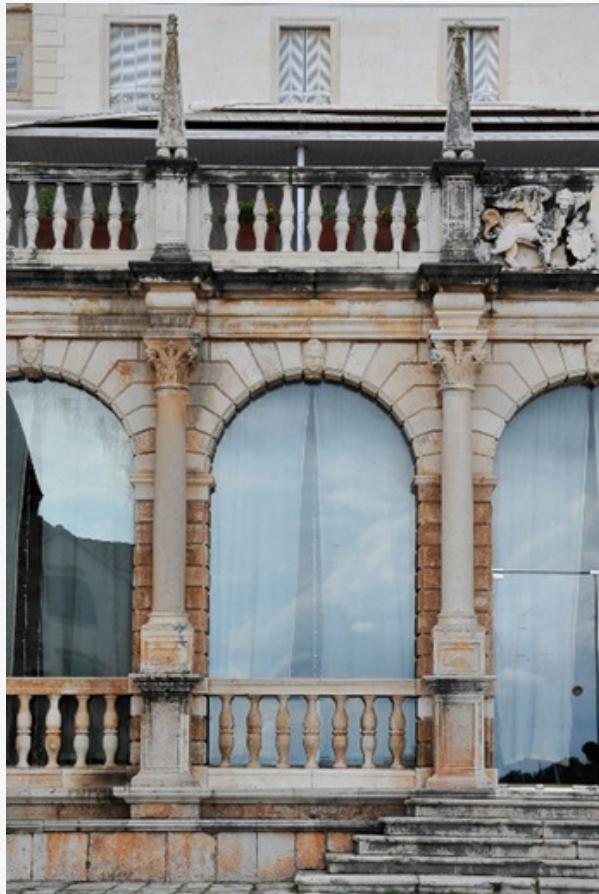
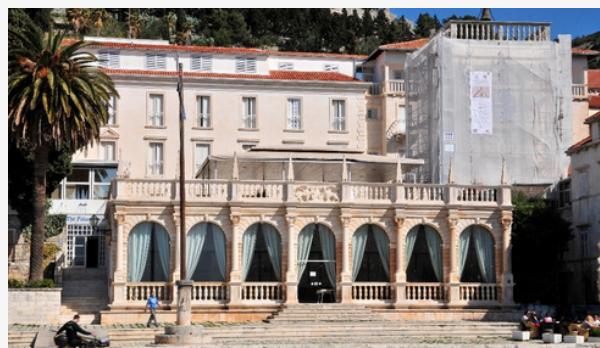
△ Hvar Loggia before and after restoration

Restorations of the façade of the Loggia, then the façade of the Clock Tower, and finally Porta Badoer, one of the five gates of the defensive walls, followed one another over the years. Impressive medieval wall and, although embedded in the stratification of later constructions, still visible and partly well preserved. Both the 15th-century Loggia, remodelled in the 16th century by the military architect Sanmicheli, and the adjacent Clock Tower, also remodelled several times, are the two distinctive elements of the architectural heritage of this little town. Investigations carried out

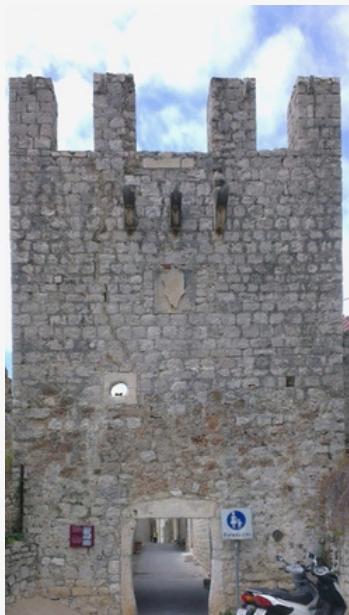
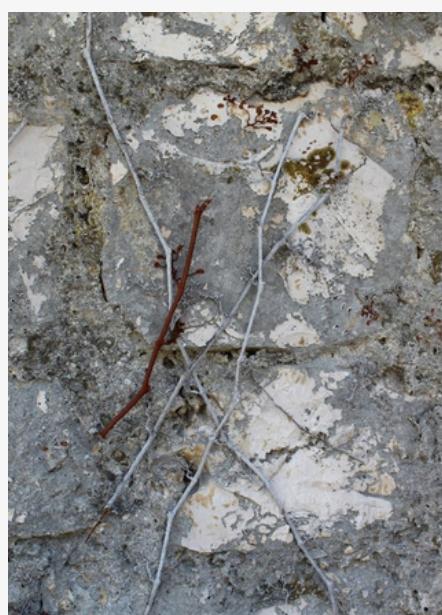
△ Before and after the restoration of Porta Badoer in Hvar and a detail of the decay (Hvar), Croatia

Since the primary cause of degradation was the attack by microorganisms, with alveolisation and degrading pathologies caused by lichenic acids, the first intervention consisted of applying **Biotin T** in 3% water, supported by cellulose pulp, and left in place for the time necessary to soften the microorganisms, and allow their removal with sorghum brushes and low-pressure cleaners.

Application of **Biotin T** by spray and/or brush: the application will be repeated several times every few days, in some areas supporting the biocide in a cellulose pulp pack.

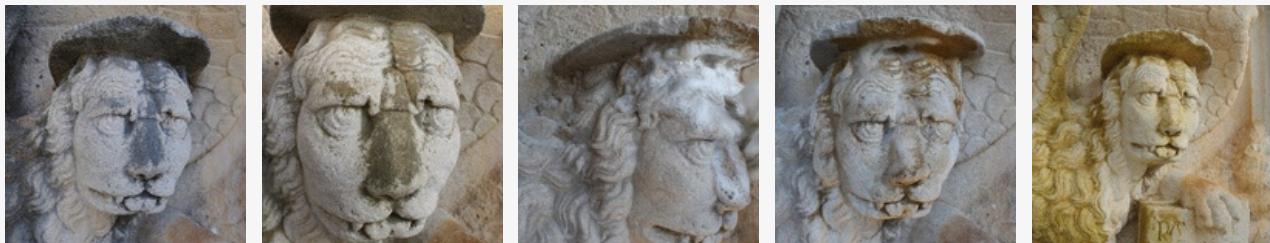
△ Biological colonisation, Loggia and Porta Badoer in Hvar, Croatia

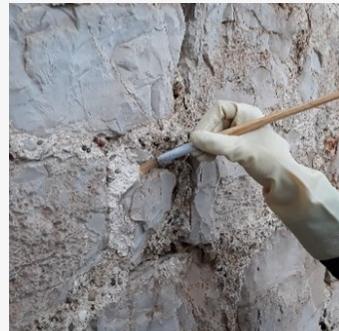
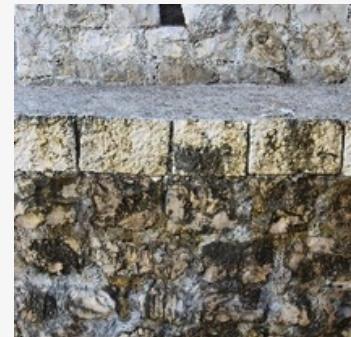
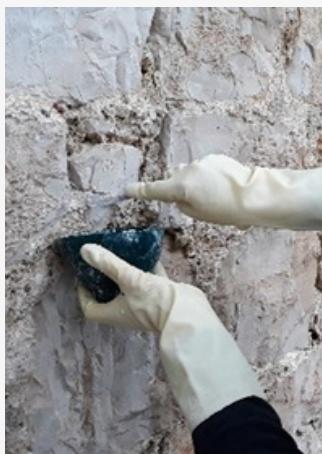
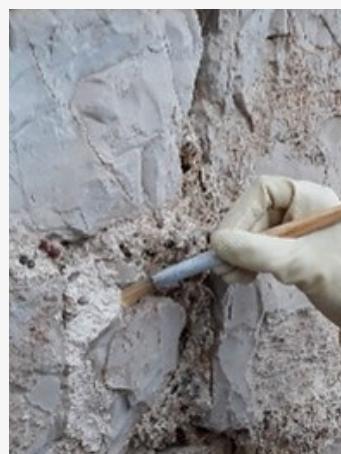
The phenomenon of erosion of almost all mortar joints in the façade leads to a deposit of rainwater and humidity, with progressive further erosion of the joints themselves.

To consolidate the most deteriorated areas, ethyl silicate (**Estel 1000**) was applied, which allows the deepest areas to be reached, followed by nanocalcium (**Nanorestore**), which leads to a re-aggregation of the surface through the formation of calcium carbonate.

This choice made it possible to reduce the use of synthetic resins to bonding only, which was carried out with liquid epoxy (**Epo 150**) and paste epoxy (**Epo 121**).
